POLREP No. 5

Date: November 18, 2000
Subject: Hackberry Pits
From: OSC Robert M. Ryan, P.E., U. S. EPA Region 6
To: Director, ERD
Charles A. Gazda, Chief, RPB, Region 6

A. Incident Category: Abandoned Oil Production Facility

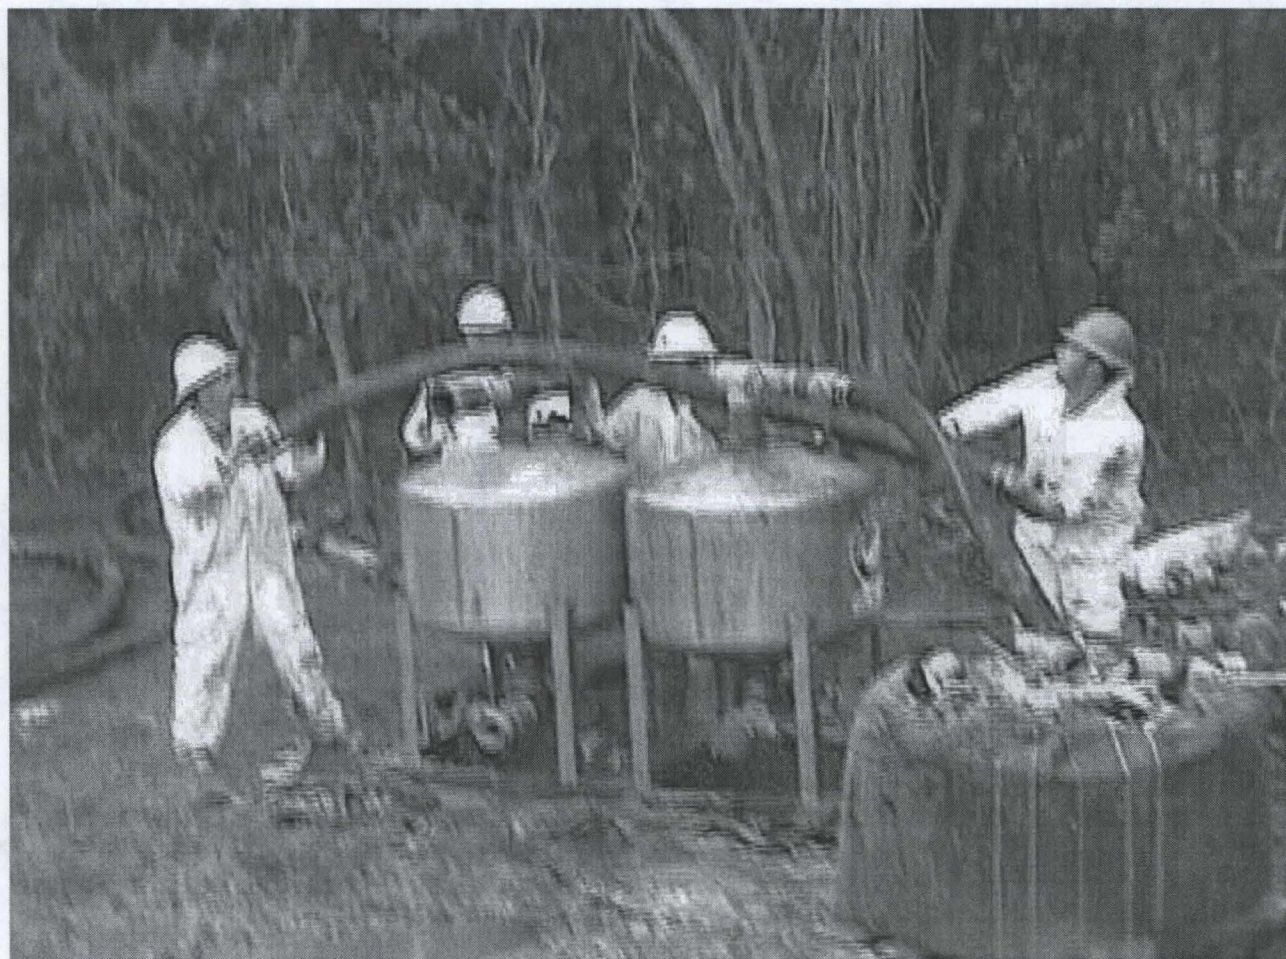
Contractor installing water treatment system.
Processed water being discharged into Pit 6..
